Attachment C

3.14 HANSY MINE (Site No. WL-516)

3.14.1 Site Location and Access (Figure 2.1-1b)

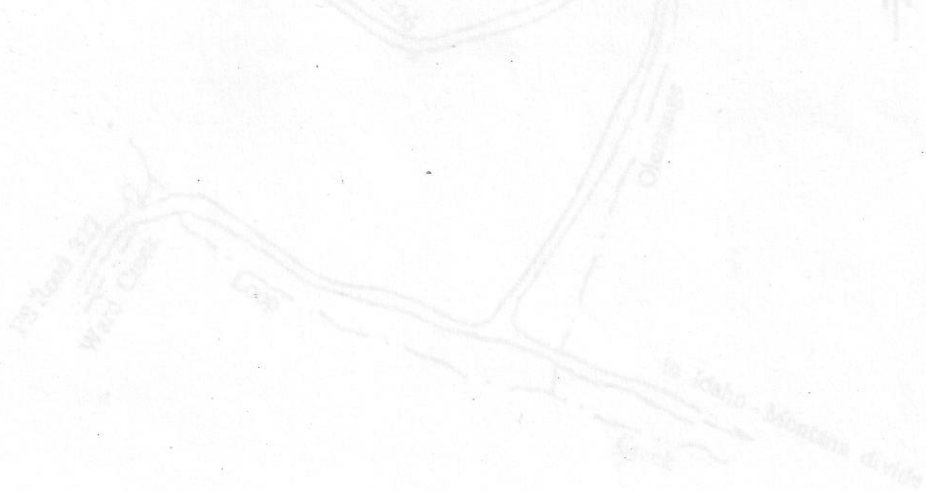
Figure 3.14-2. Sketch map of the Hansy Mine workings examined for this study.

Six adits and five prospect cuts were described at the Hansy property (Figure 3.14-2). Five additional prospects shown on the topographic map were not visited. The adits and prospect cuts discussed below are numbered in the order in which they were examined.
