Final Report
Volume 1 of 3

U.S. 95, Bellgrove to Mica
Project No. DHP-NH-CM-5110(119)

**Mica Bay and Mica Creek
Final Impact Assessment**

Prepared for
**Idaho Transportation Department and
Idaho Department of Environmental Quality**

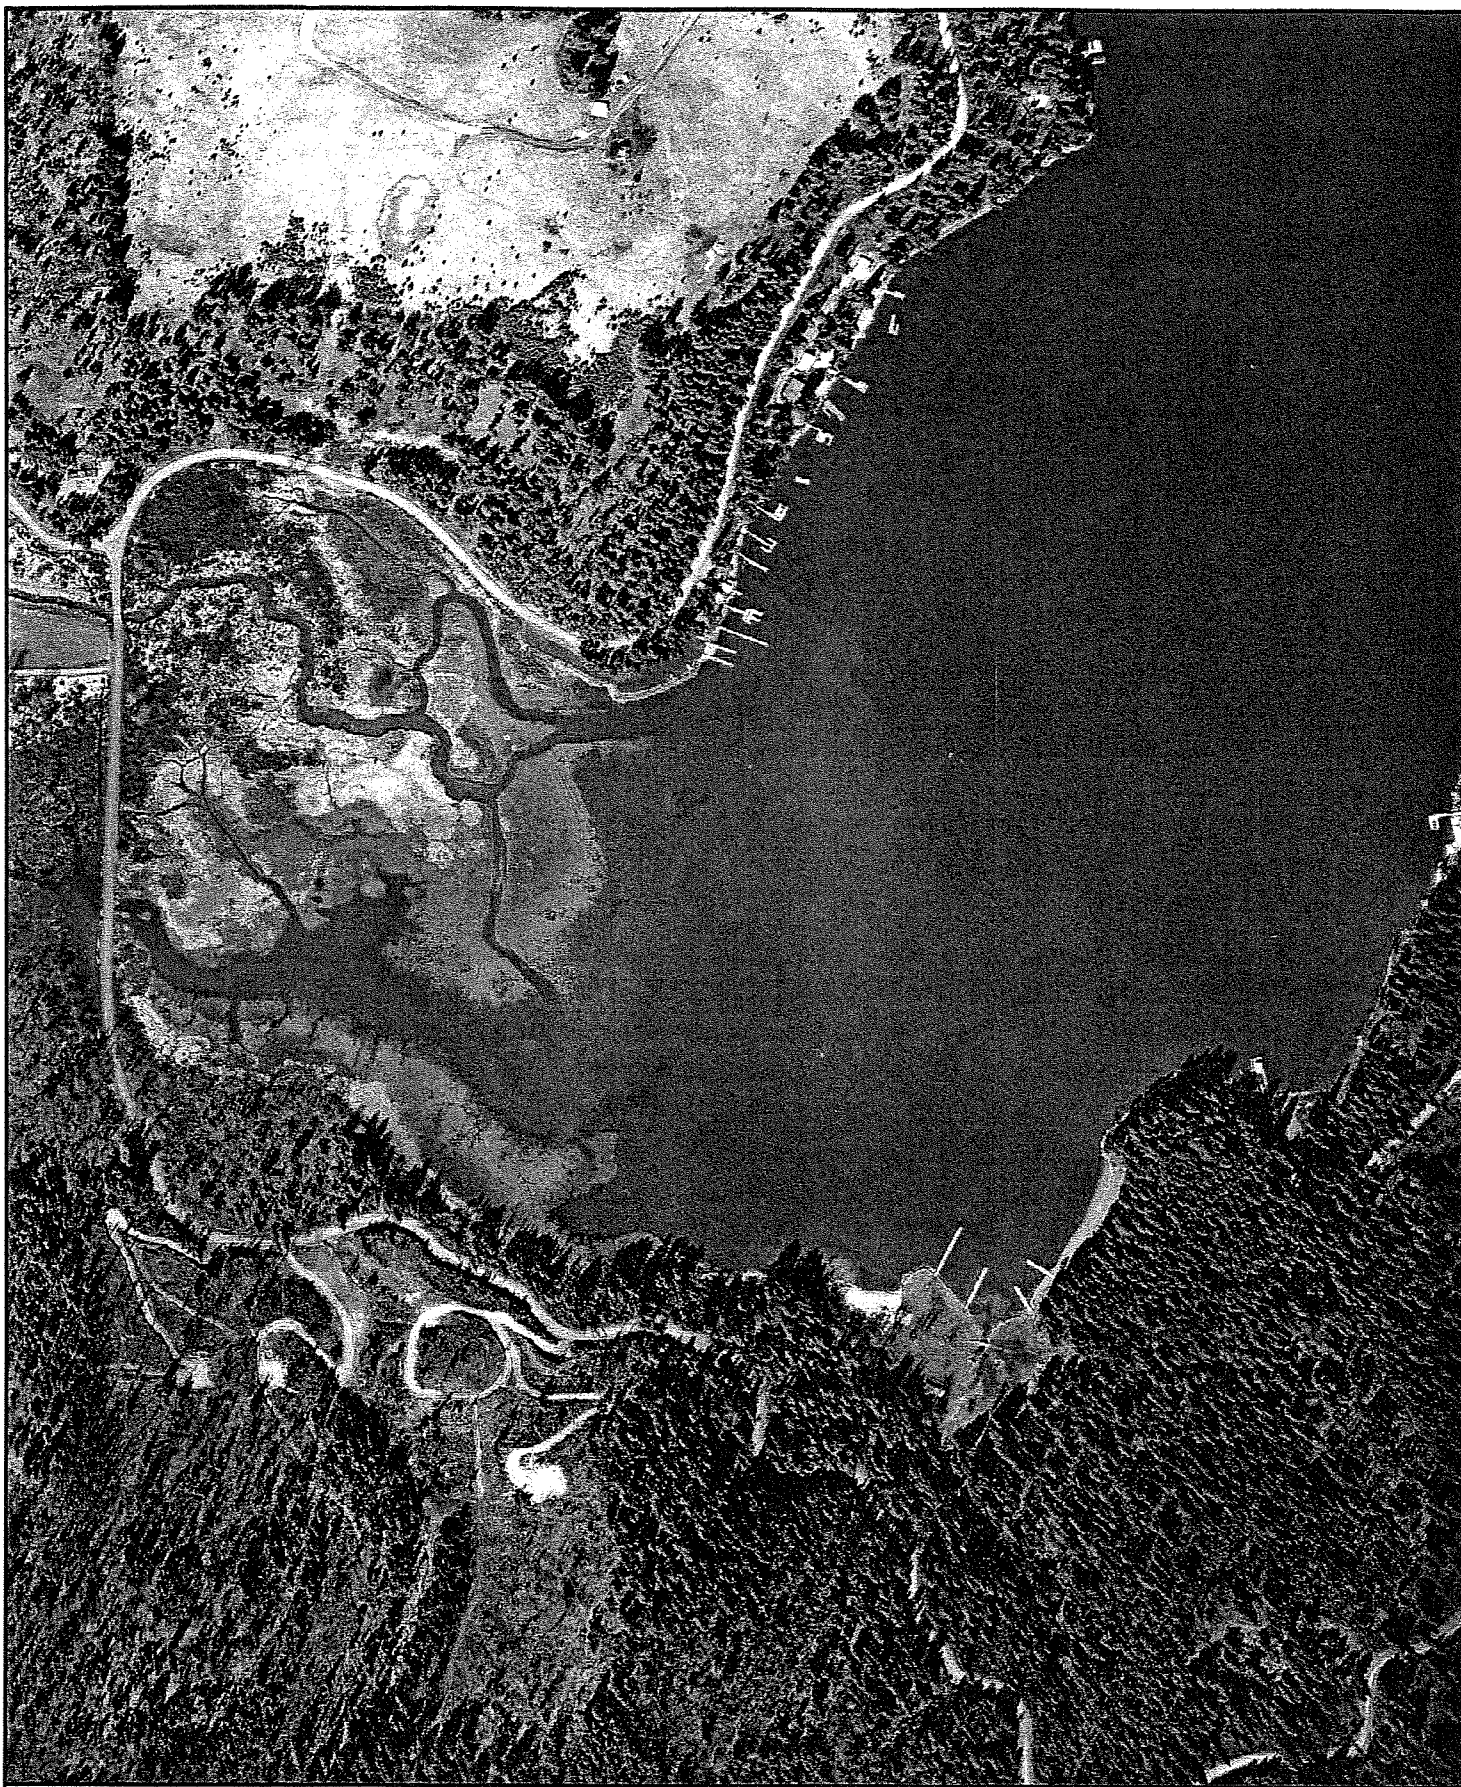
Source: Idaho Transportation Department
Date: April 19, 1999
Water Surface Elevation: 647.2 m (2,123.2 ft)
0 500 1,000 Feet

FIGURE 4-2
Mica Bay Aerial Photography
MICA BAY AND MICA CREEK
FINAL IMPACT ASSESSMENT
IDAHO TRANSPORTATION DEPARTMENT

A discussion of delta morphology can be found in Schumm (2003), so only a few observations and discussion points regarding similarities and differences in the pre-project delta morphology exhibited by the historical photos are presented here. The most significant observation is the similar shape and extent of the delta margin and remnant distributary channels of Mica Creek. For example, the delta margin is clearly visible east of the Kootenai County boat ramp in the 1965 photo (see Photo 1965-1-B in Appendix H). In addition, the shape and alignment of what appear to be remnant distributary channels and perhaps even channels formed by underwater springs have remained relatively constant since the earliest photographs (see Figure 4-1). On the other hand, the most significant difference between the 1965 and 1999 photos appears to be the alignment shift that occurred in the primary channel approximately half-way across the delta. Some time between 1965 and 1999 this channel either gradually or abruptly migrated northward and elongated the delta lobe at the mouth. A fan-shaped lobe is apparent in the 1965 photograph at the mouth (delta margin) of the primary channel; however, the subsequent channel shift resulted in the formation of another fan-shaped lobe to the northeast. This fan, and part of the remnant fan just to the southeast can be seen in Figure 4-2. It appears from the 1984 photo that the channel avulsion to the

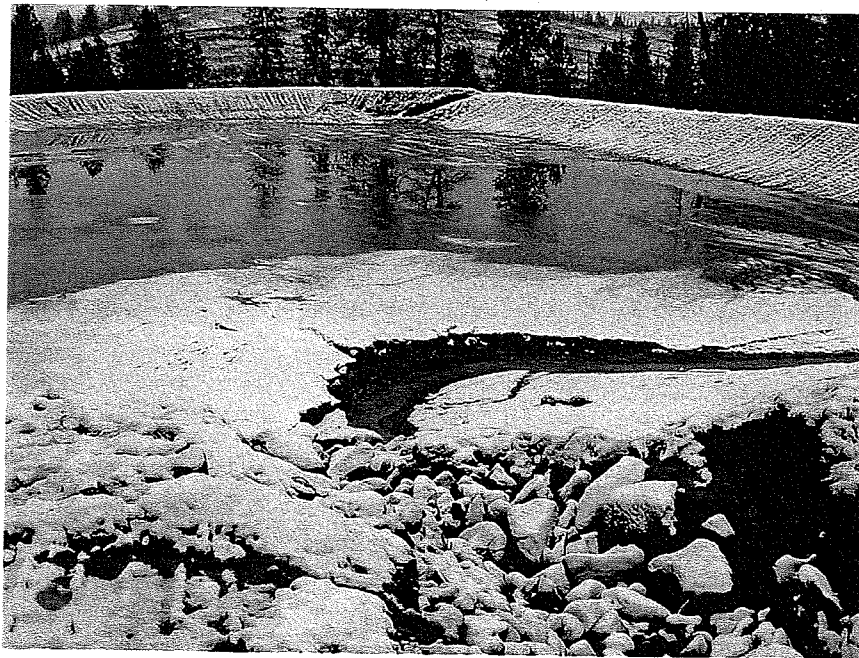
On October 23, 2001, the sediment pond embankment was breached by seepage erosion in the area of the outlet pipe of the basin. Although two precipitation events (0.63 inch in 2 days) with air temperatures well above freezing (ranged from 38 to 58 degrees F) occurred coincident with the breach, they likely did not cause it. Neither the spillway nor the embankment were over-topped during these events. ITD construction diaries (see Appendix K) show that turbid conditions decreased noticeably within 2 days. Turbidity levels were less than 20 NTU at all sample locations downstream of the project on October 26, 2001. The Contractor made some repairs to the embankment and the sediment basin was put back into operation. On November 23, 2001, the sediment basin embankment was breached at this same location. Again, three precipitation events (1.01 inches in 3 days) with air temperatures that ranged from 29 to 54 degrees F occurred coincident with the second breach. Again, these events did not lead to over-topping of the spillway or embankment. The second breach was also caused by seepage erosion in the area of the outlet pipe. ITD estimated that approximately 270 cubic yards of soil material from the breached embankment was washed downstream. It is estimated that about half of this material entered the South Fork Mica Creek. The remaining material was deposited in the unnamed tributary downstream of the sediment basin before entering the South Fork Mica Creek. Photo 6-1 shows the sediment pond subsequent to the second breach. In the foreground is an accumulation of sediment near the inlet to the basin. The breach is shown in the upper portion of the photo. It is clear that the size of the breach represented a small portion of the total embankment. ITD's calculations also indicate that approximately 15 cubic yards of material was eroded from the down-cutting of the basin bottom within the basin. ITD subsequently removed the sediment basin from use, and the sediment basin site was restored to natural conditions during the 2002 construction season.

Photo 6-1 Sediment Pond after Second Breach

A sediment basin was constructed near the south end of the South Fork Mica Creek canyon during the summer of 2001. As discussed in more detail in Chapter 6, the embankment of the sediment basin was breached in the fall of 2001. ITD subsequently removed the sediment basin from use, and the sediment basin site was restored to natural conditions during the 2002 construction season.
