# COEUR D'ALENE BASIN NATURAL RESOURCE DAMAGE ASSESSMENT AND RESTORATION ACCOMPLISHMENTS

## RESTORATION ACTIVITIES 2007-2008

PREPARED OCTOBER 2009 BY THE COEUR D'ALENE BASIN TRUSTEES

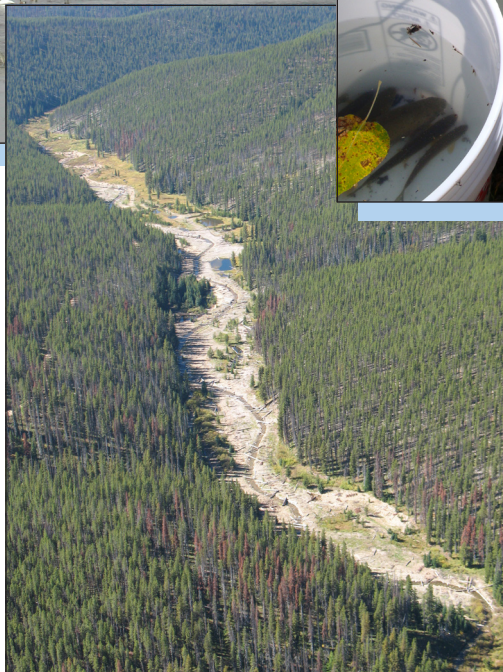
*Sherlock Creek, Idaho - Fish Habitat and Stream Channel Restoration*

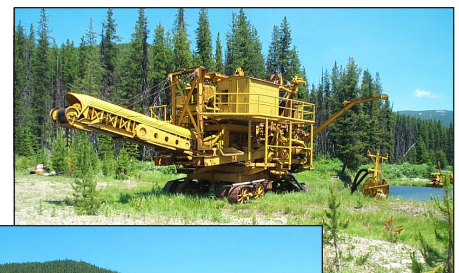
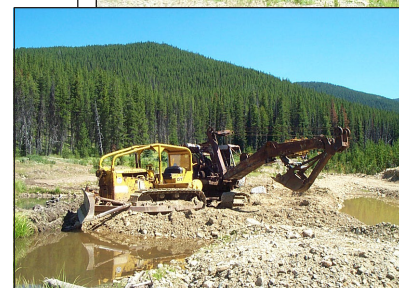
Equipment removal at the Sherlock Creek Site.

Nearly 100 tons of contaminated (hydrocarbon) soils and appreciable amounts of trash were removed from the site. In addition, logs and root wads were brought to the site and staged for the next phase of work: stream restoration.

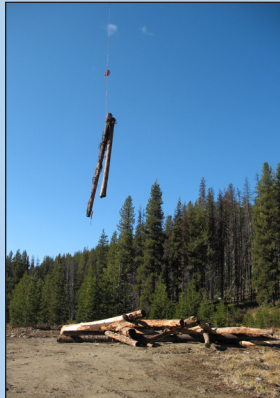
*Helicopter long lining logs to the Sherlock site.*

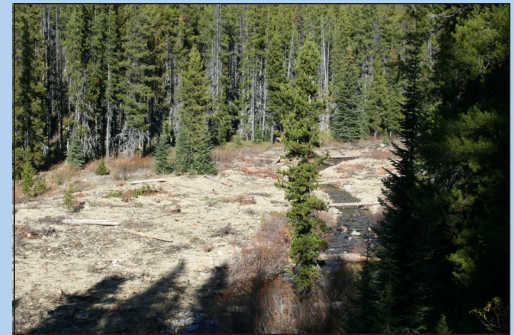
*(10/29/08) Upstream end of project area - stream construction area begins.*

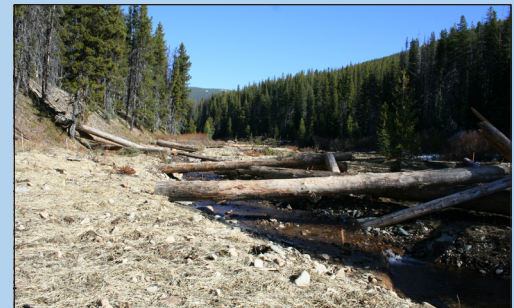
*(10/29/08) Upper section of new channel - base flow only in stream for winter/spring 09.*

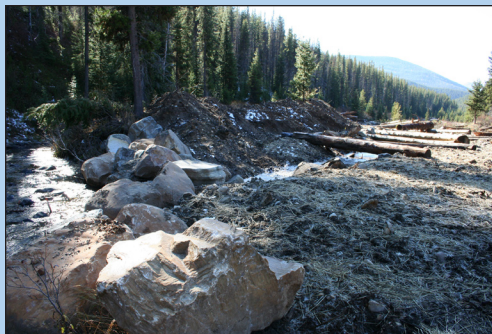
*(10/29/08) Looking downstream - old channel on the left, new channel on the right, stockpiled soil in the middle for 2009 work. Temporary flow control intersection provides some flow to the new channel to help with revegetation, especially willow staking.*

In 2009, restoration will include removing two temporary diversions on reconstructed stream channels that were left in place in 2008 to allow the newly planted vegetation to become established before experiencing full stream flows. Recontouring and revegetation of the old stream channel section will also occur. Monitoring will be focused on assessing effectiveness and stability of the restoration. Significant maintenance in out years at the site is not planned or anticipated.

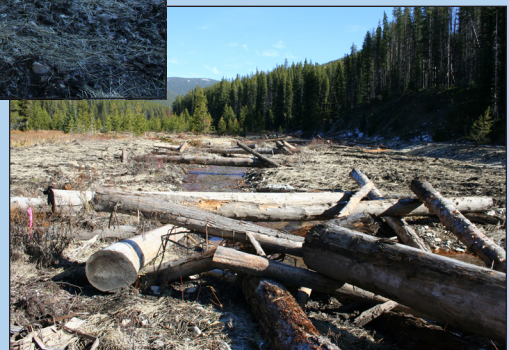
*(10/29/08) Lower end of project area near road.*

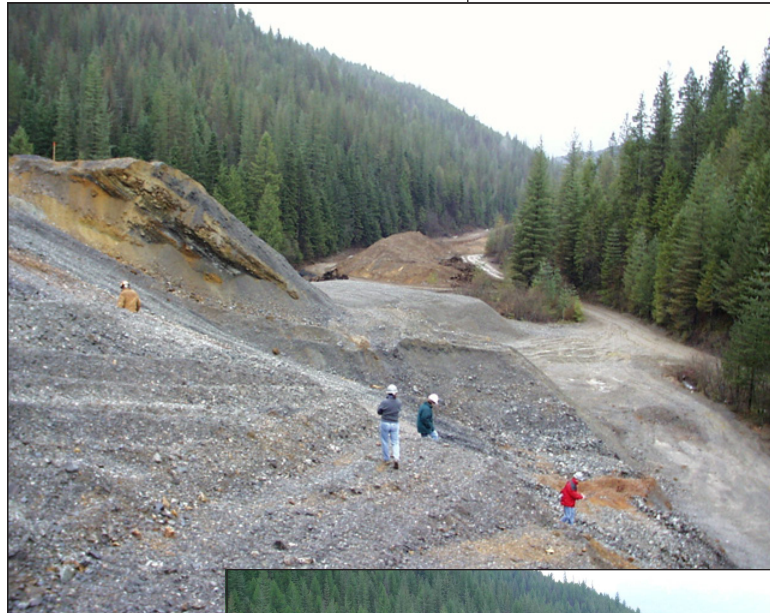
*Moon Creek waste rock.*

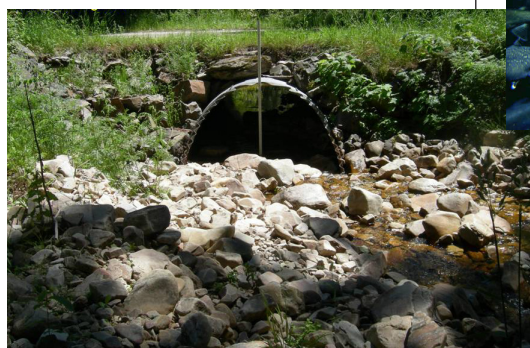
**LANGLOIS SITE:** The largest culvert installation was on Langlois Creek. The pipe was undersized and improperly sloped causing bedload deposition within the culvert. It was also a fish passage barrier and Shoshone County needed to cleanout and maintain the culvert even after moderate runoff events. Following the 1996 flood, the BLM invested flood restoration dollars in Langlois Creek, both up and downstream of this culvert, in part to restore fish passage from the West Fork of Pine Creek.

Undersized culvert at Langlois Creek Road Crossing, 2007.

A bottomless arch pipe with pre-cast concrete footings was installed at the Langlois site in the fall of 2007. The new pipe's capacity is sized to better match the existing channel width, and the installation more closely matches the natural slope and width of the channel. Riprap was used to armor the inlet, and to construct buried rock grade controls to prevent channel incision within and downstream of the culvert. Shoshone County joined BLM and the Trustees in accomplishing this project by providing dump trucks to haul needed materials.

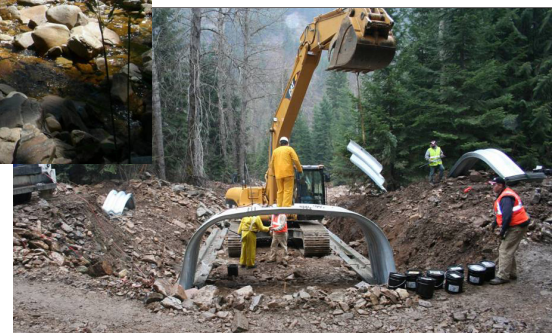
Installing replacement culvert at Langlois Creek, November 2007.

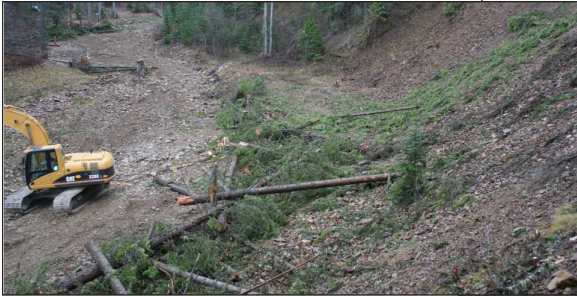
*Constructing slope protection along Trapper Creek, 2007.*

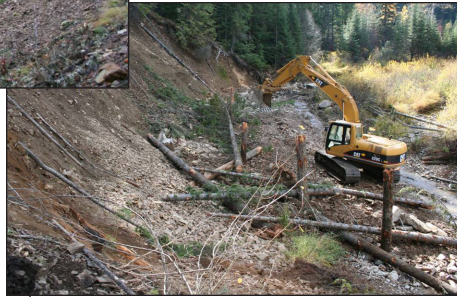
*Constructing toe slope protection with onsite materials, near Calusa Creek, August, 2007.*

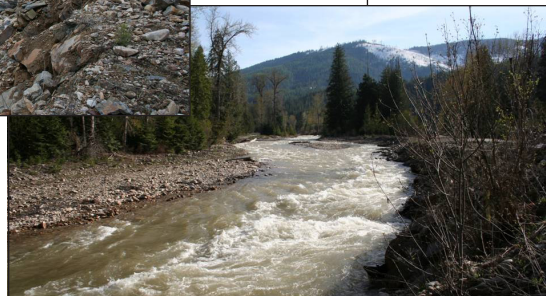
*Flow deflection from rock barbs at high flow, West Fork of Pine Creek, May, 2008.*

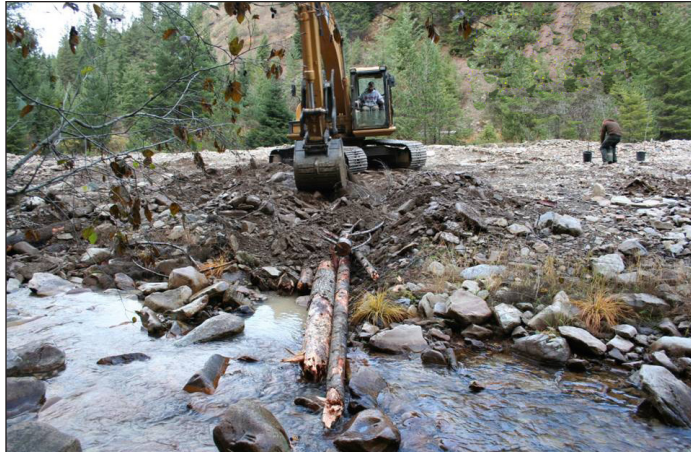
*Installing logs and riparian plantings to enhance bank stability on the East Fork of Pine Creek, fall, 2008.*

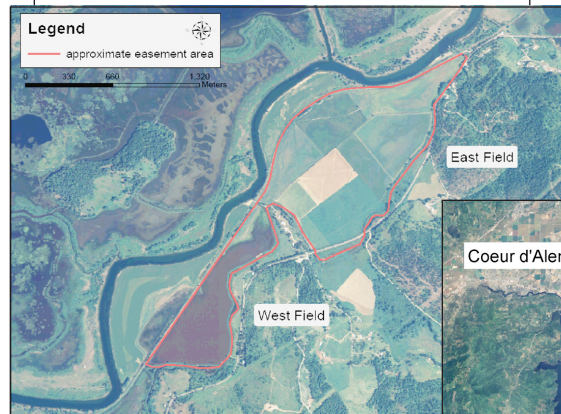
*Coeur d'Alene Basin wetland restoration, project site location and easement area.*

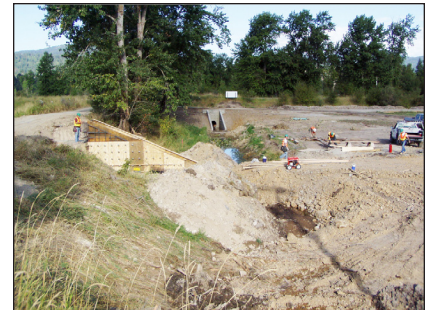
*East field water control structure construction, September, 2007.*

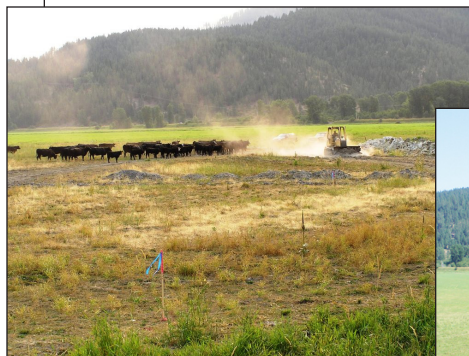
*East field agricultural ditchfilling, summer, 2007.*

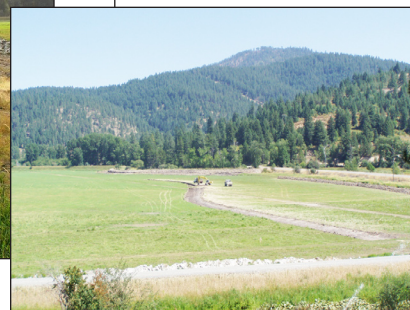
*East field swale construction, August, 2007.*
